Manhole Inspection Summary

Manhole # S31WW1017MH

Insp Date: **1/23/07 12:36 PM**

Location Address: **110 ENFIELD RD**

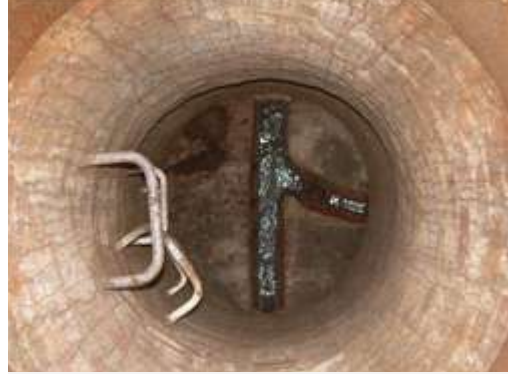
Top View

☒ **Debris** (not Condition related)

Bench debris.

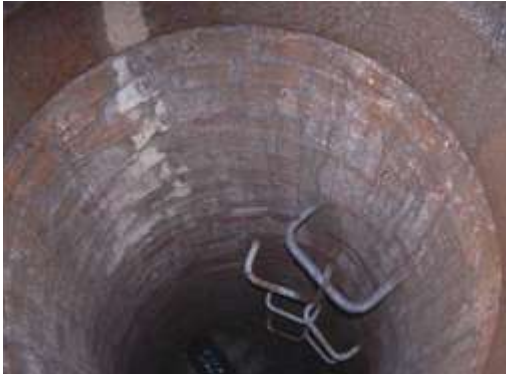
Defect

☒ **Leaks**

Infiltration: ☐ None ☒ **Joint** ☐ Cracks ☐ Mortar ☐ Roots ☒ **Wall**

Frame leaks. Adjustment infiltration - other side.

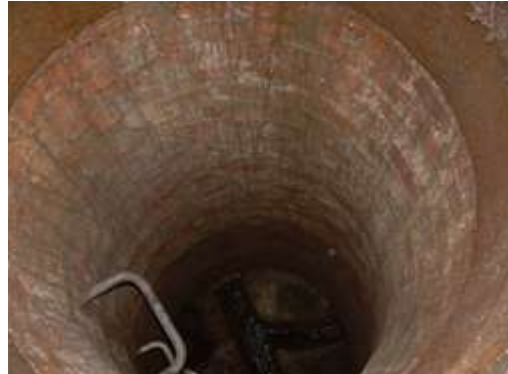
Defect

Frame leaks. Adjustment infiltration.

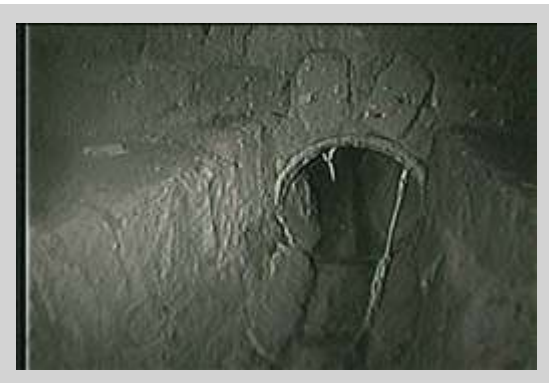
6 in. Circular Gravity Sewer Pipe In @ 3 O'Clock

Infiltration: **Evidence** Pipe Seal Cond: **Roots**

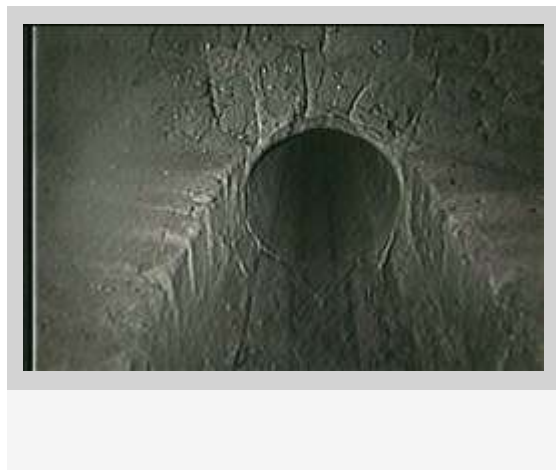
8 in. Circular Gravity Sewer

Infiltration: **Evidence**

Pipe Seal Cond: **Cracked**
